# WELDING INSPECTION REPORT

**OSM Arrival Time:** 700 **Project Name:** SAS Superstructure **OSM Departure Time:** 1900 **Prime Contractor:** American Bridge/Fluor Enterprises, a JV

34-0006 **Bridge No: Component:** OBG.

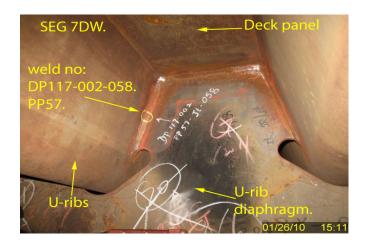
#### PP57-DP117-002 - 058.

One (1) transverse linear indication was discovered measuring approximately 6mm in length. The member is identified as the deck panel diaphragm, fillet weld connection to U-ribs. This indication is located outside the area that has been previously tested and accepted by ZPMC Quality Control (QC) personnel. This QA informed ZPMC Quality Control (QC) identified as Mr. Wang Wei Ming and American Bridge Fluor (ABF) QA identified as Mr. Peter Shaw of this issue and that an incident report would be generated.
